# Manhole Inspection Summary

## Manhole # S33GG1018MH

Insp Date: **2/5/07 9:21 AM**

**Location** Address: **3959 CLOVERHILL RD** Cross Street: **HIGHFIELD RD**

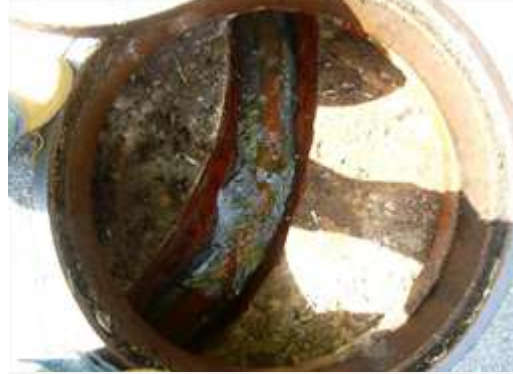
Top View

**Bench** ☒ Exists Material: **Brick** ☐ Parged ☒ **Debris** (not Condition related)  
Condition: ☒ Sound ☐ Cracked ☐ Root Intrusion ☐ Deteriorated ☐ Leaks ☐ Debris

**Surcharge** ☒ **Evidence Of Surcharge** Depth: **1** (ft.) ☐ Active Surcharge Present

Evidence of surcharge - Bench debris.

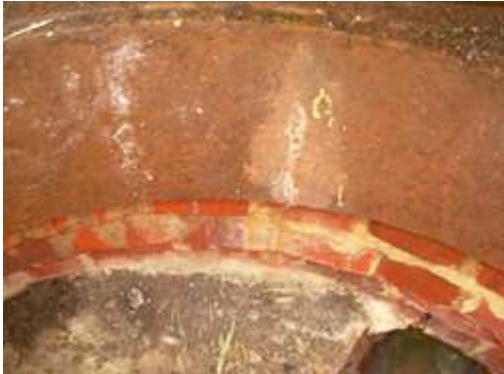
Defect

**Frame** Offset: **0** (in.) Condition: ☐ Sound ☐ Cracked ☒ **Leaks**

**Corbel** Material: **Brick** ☐ Parged Type: **Concentric/Eccentric**  
Condition: ☒ Sound ☐ Cracked ☐ Root Intrusion ☐ Loose Brick ☐ Deteriorated  
Infiltration: ☐ None ☒ **Joint** ☐ Cracks ☒ **Mortar** ☐ Roots ☐ Wall

**Barrel** Material: **Brick** ☐ Parged  
Shape: **Circular** Diameter: **48** (in.) Length: (in.)  
Condition: ☒ Sound ☐ Cracked ☐ Root Intrusion ☐ Loose Brick ☐ Deteriorated  
Infiltration: ☐ None ☐ Joint ☐ Cracks ☒ **Mortar** ☐ Roots ☒ **Wall**

Frame leaks. Corbel and Barrel infiltration.

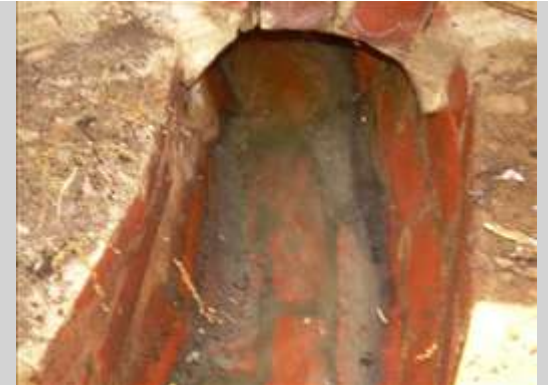
### 8 in. Circular Gravity Sewer Pipe Out @ 12 O'Clock

Infiltration: **Evidence** Pipe Seal Cond: **Cracked**
